Manhole Inspection Summary

Manhole # S07WW1004MH

Location Address: **5712 BLAND AVE**

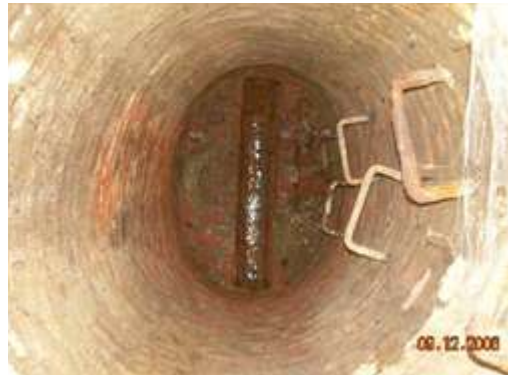
Top View

Corroded steps. Evidence of surcharge - Bench debris.

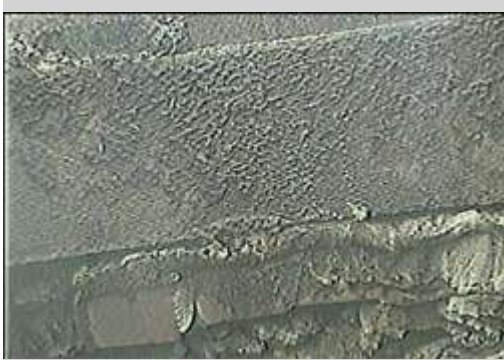
Defect

Frame leaks. Adjustment deterioration and infiltration.

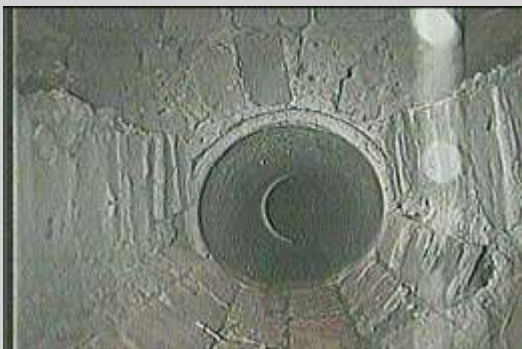
Pipe In @ 6 O'Clock

Channel deterioration.
